National Dam Inspection Program. Eberle  
Dam (NDI PA 036, PA-456), Susquehanna  
River Basin, Closes Creek, Tioga County,  
Pennsylvania. Phase I Inspection Report.

PHASE I REPORT  
National Dam Inspection Program

PA-456 Dam (Eberle Dam): NDS I.D. No. PA-00036

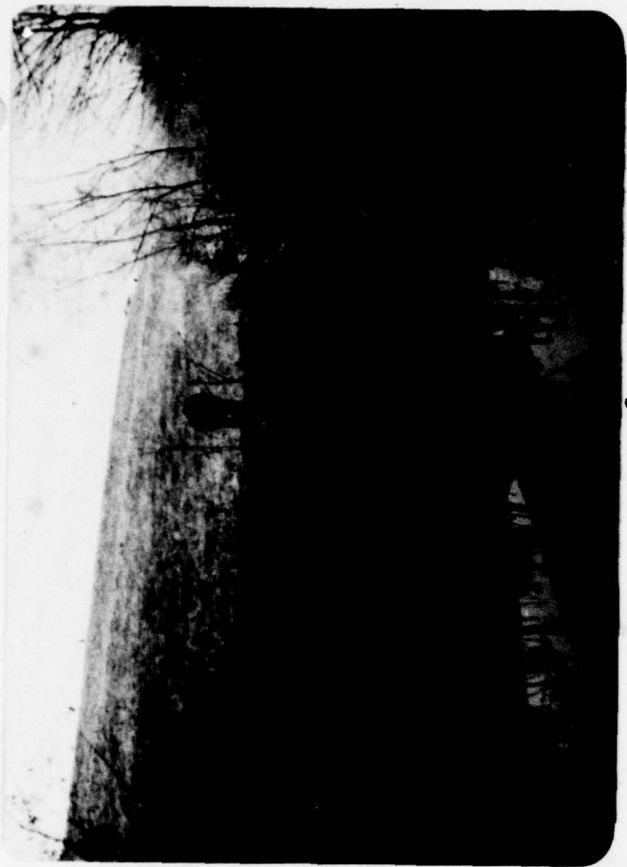
6

3. Outlet Conduit. The visible portion of the outlet conduit (see Photograph 6) was found to be in excellent condition. No evidence of concrete deterioration, misalignment or other irregularities were discernible.

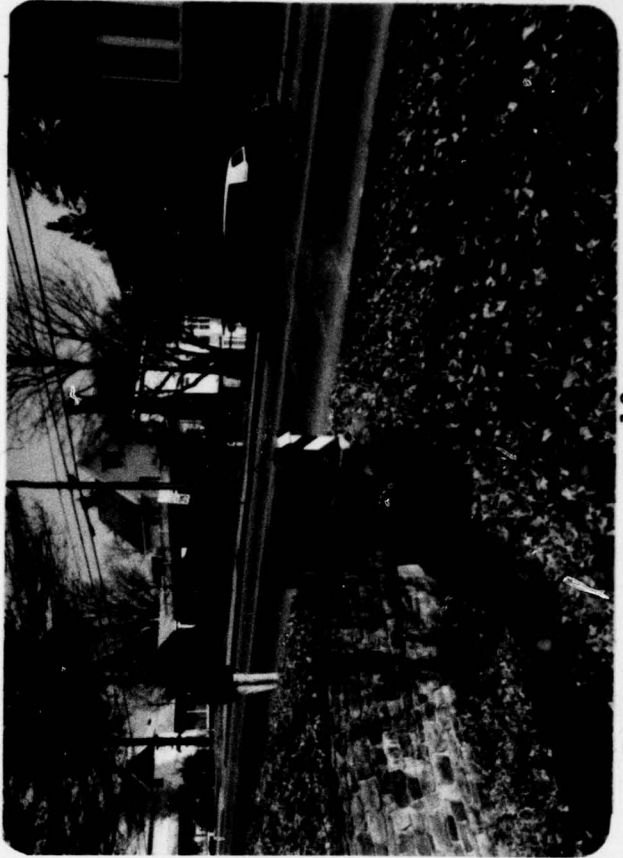
10

View 2,000 feet downstream of the embankment showing the culvert which passes the flow beneath Pennsylvania Route 349 at the southern boundary of the Borough of Westfield. The leather tanning factory is located across the road on the right side of the photograph.
